Manhole Inspection Summary

Manhole # S33QQ_043MH

Location Address: **2501 25TH ST**

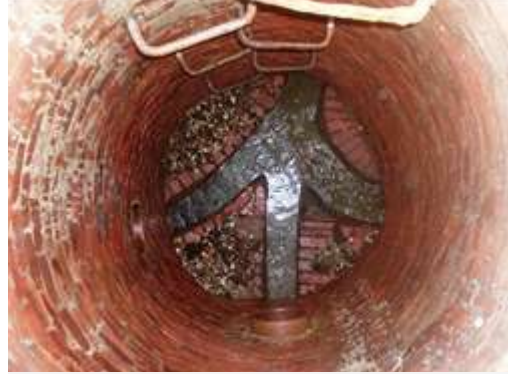
Top View

Count: **5** Missing: **0** ☒ **Corroded**

Corroded steps. Bench debris.

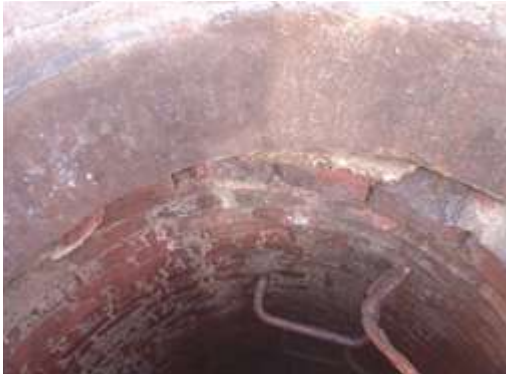
Defect

☒ **Leaks**

Condition: ☐ Sound ☐ Cracked ☐ Root Intrusion ☒ **Loose Brick** ☒ **Deteriorated**

Infiltration: ☐ None ☒ **Joint** ☐ Cracks ☒ **Mortar** ☐ Roots ☐ Wall

Infiltration: ☐ None ☐ Joint ☐ Cracks ☒ **Mortar** ☐ Roots ☒ **Wall**

Frame leaks. Adjustment loose brick, deterioration and infiltration. Corbel infiltration.

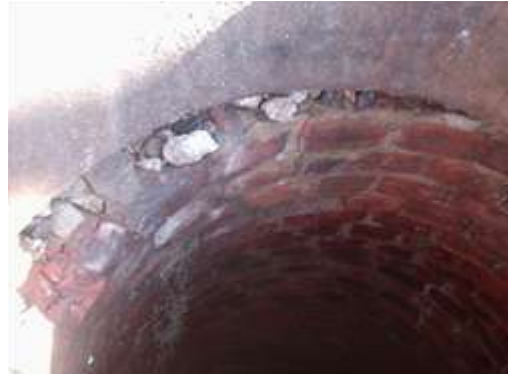
Defect

Offset: **3** (in.)

Frame leaks. Frame offset. Adjustment loose brick, deterioration and infiltration. Corbel infiltration - other side.

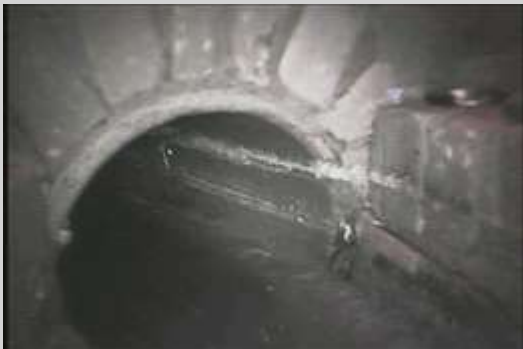
10 in. Circular Gravity Sewer Pipe In @ 3 O'Clock

Deposits: ☐ None ☐ Mud ☐ Sludge ☐ Debris ☒ Grease

Silt Depth: **0** (in.) Deposits Extent: **Light**

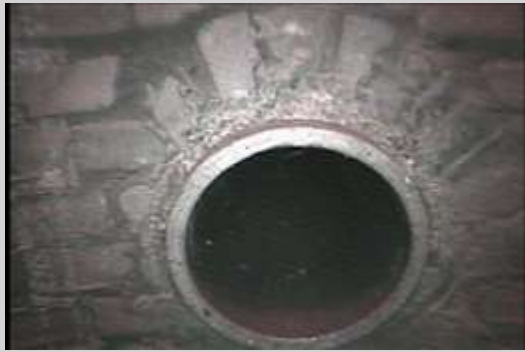
8 in. Circular Gravity Sewer

Infiltration: **None** Pipe Seal Cond: **Broken**

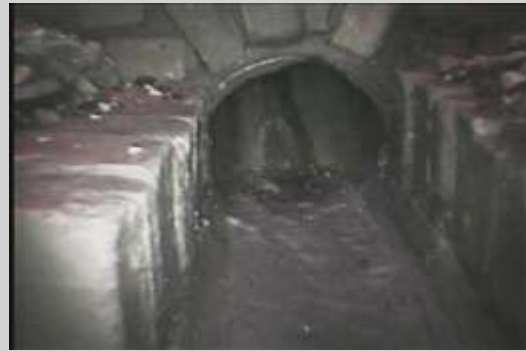
Drop In @ 6 O'Clock

Condition: ☐ Sound ☐ Cracked ☐ Root Intrusion ☒ **Deteriorated** ☐ Leaks ☐ Debris

Bench deterioration.

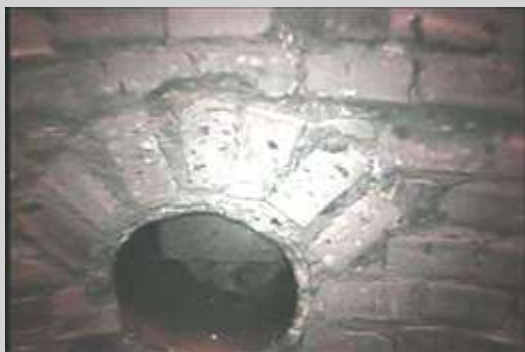
8 in. Circular Gravity Sewer

Condition: ☐ Sound ☐ Cracked ☐ Root Intrusion ☐ Loose Brick ☒ **Deteriorated**

Infiltration: ☐ None ☐ Joint ☐ Cracks ☒ **Mortar** ☐ Roots ☐ Wall

Barrel deterioration and infiltration.

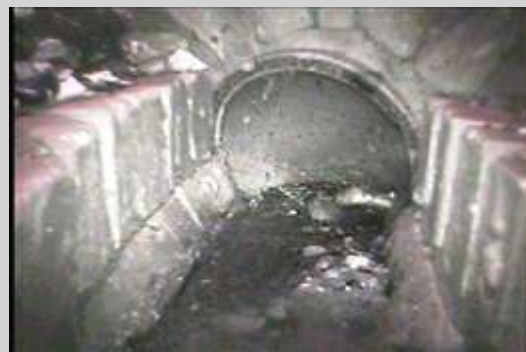
Drop In @ 8 O'Clock

Condition: ☐ Sound ☐ Cracked ☐ Root Intrusion ☒ **Deteriorated** ☐ Leaks ☐ Debris

Channel deterioration.
